SUBJECT: BYRON STATION, UNITS 1 AND 2 SPECIAL INSPECTION - DEGRADATION
OF THE ESSENTIAL SERVICE WATER RISER PIPING TO THE COOLING
TOWER BASIN 05000454/2007009(DRS) AND 05000455/2007009(DRS) AND
PRELIMINARY WHITE FINDING

IR 05000454/2007009(DRS) and 05000455/2007009(DRS); 10/23/2007 - 02/14/2008; Byron Station, Units 1 and 2; Special Inspection to evaluate the facts and circumstances surrounding the degradation of the essential service water riser piping to the cooling tower basin.

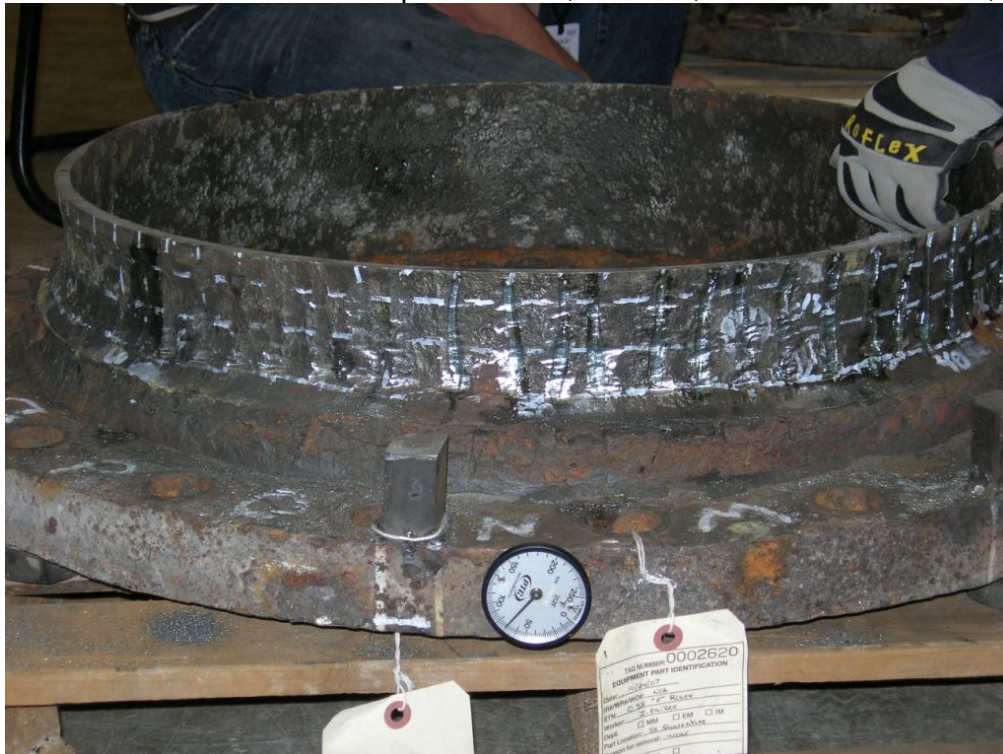
Picture No. 6 – 0F SX Riser Pipe Removed, Cleaned, with Grid- October 25, 2007

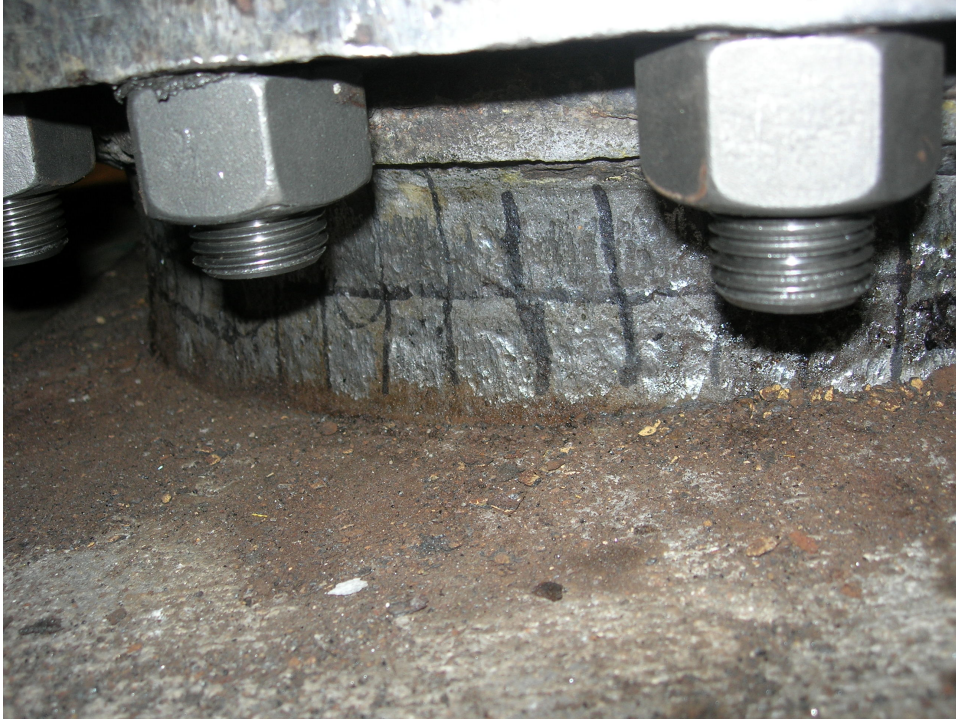
Picture No. 7 – OD SX Riser Pipe- Cleaned with Grid - October 2007

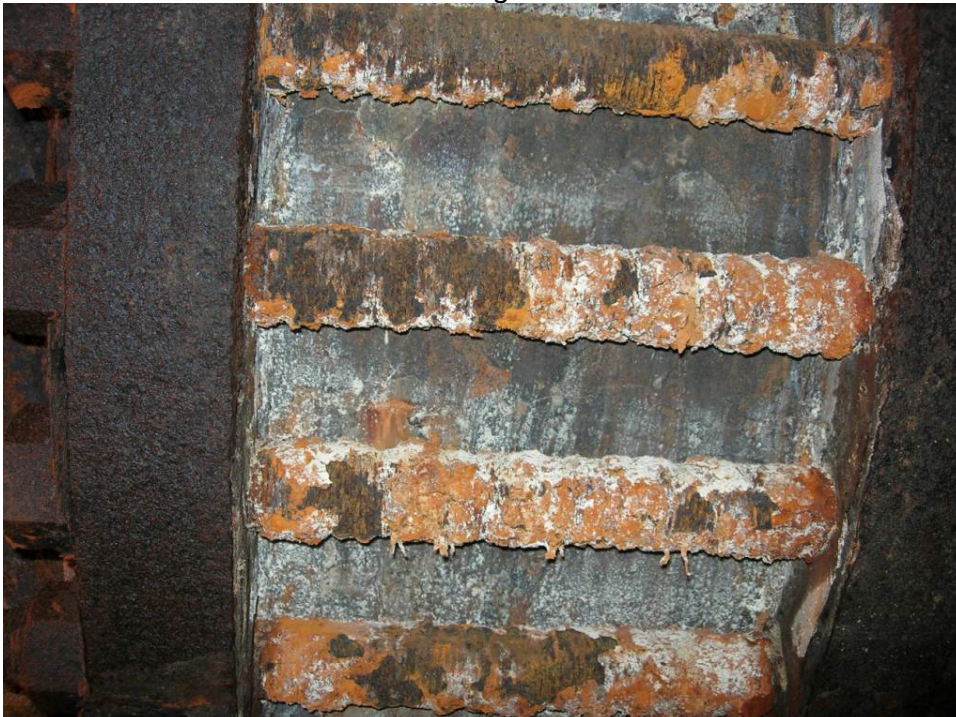
Picture No. 8– OSX 138B Valve Bolting - October 2007

- Green. The team identified a finding of very low safety significance and a Non-Cited Violation of 10 CFR Part 50, Appendix B, Criterion XVI, "Corrective Action," for the licensee's failure to identify severely corroded bolts (condition adverse to quality) on the 0B SX basin suction supply isolation valve 0SX138B. The cause of this finding was related to the Corrective Action Program Component (Item P.1(a) of IMC 305) for the cross-cutting area of Problem Identification and Resolution, because the licensee staff failed to adopt an appropriate threshold for identifying issues. Specifically, the failure of the licensee VT-2 examiner to identify these degraded bolts was related to an excessively high threshold for problem identification. The licensee entered this issue into the corrective action program and replaced the bolts on the lower half of this valve which were subjected to the most severe corrosion.
